Additional Information in Support of  
Straight Creek UAA Proposal  
and in Response to Comments at Public Meeting on January 26, 2007

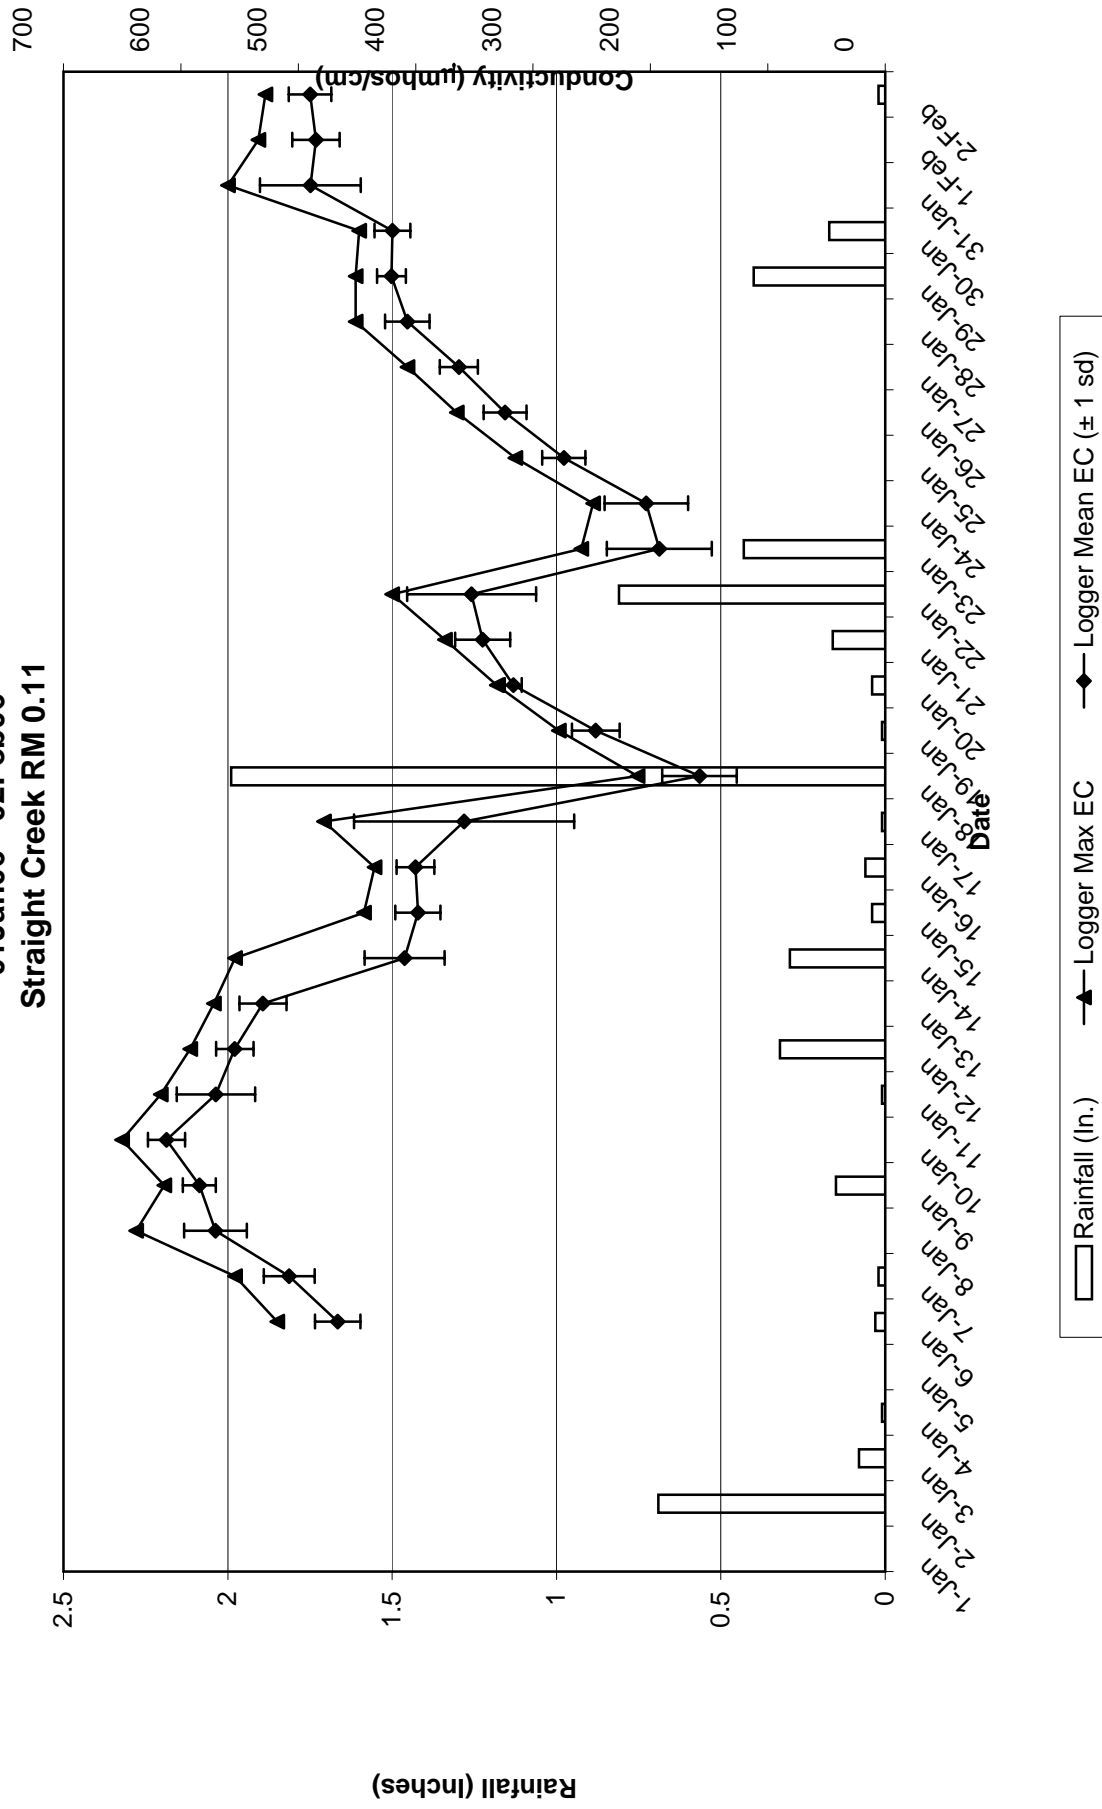
Figure 1. Specific Conductivity & Rainfall  
01 Jan06 - 02 Feb06  
Straight Creek RM 0.11

- ii. TDS concentration (not loading) is what is important to aquatic organisms (toxicity, osmotic stress, etc.).
  - iii. TDS concentration (as measured with a continuous conductivity logger) was observed to be highest during the low precipitation and/or low flow times of year (Figure 1) in Straight Creek (RM 0.11).

- iv. TDS concentration (conductivity) dropped dramatically in direct response to rainfall (Figure 1).
- v. When the TDS concentration is highest, the source cannot be attributed to overland flow (e.g. surface runoff).
